TEST
OF DU
SEAL M

TMC Program 7208-3

TEST REPORT - EVALUATION OF DUPONT *LRU 488
AS A SEAT SEAL MATERIAL IN THE MARQUARDT
R4D ENGINE VALVE

TMC PROGRAM 7268-3

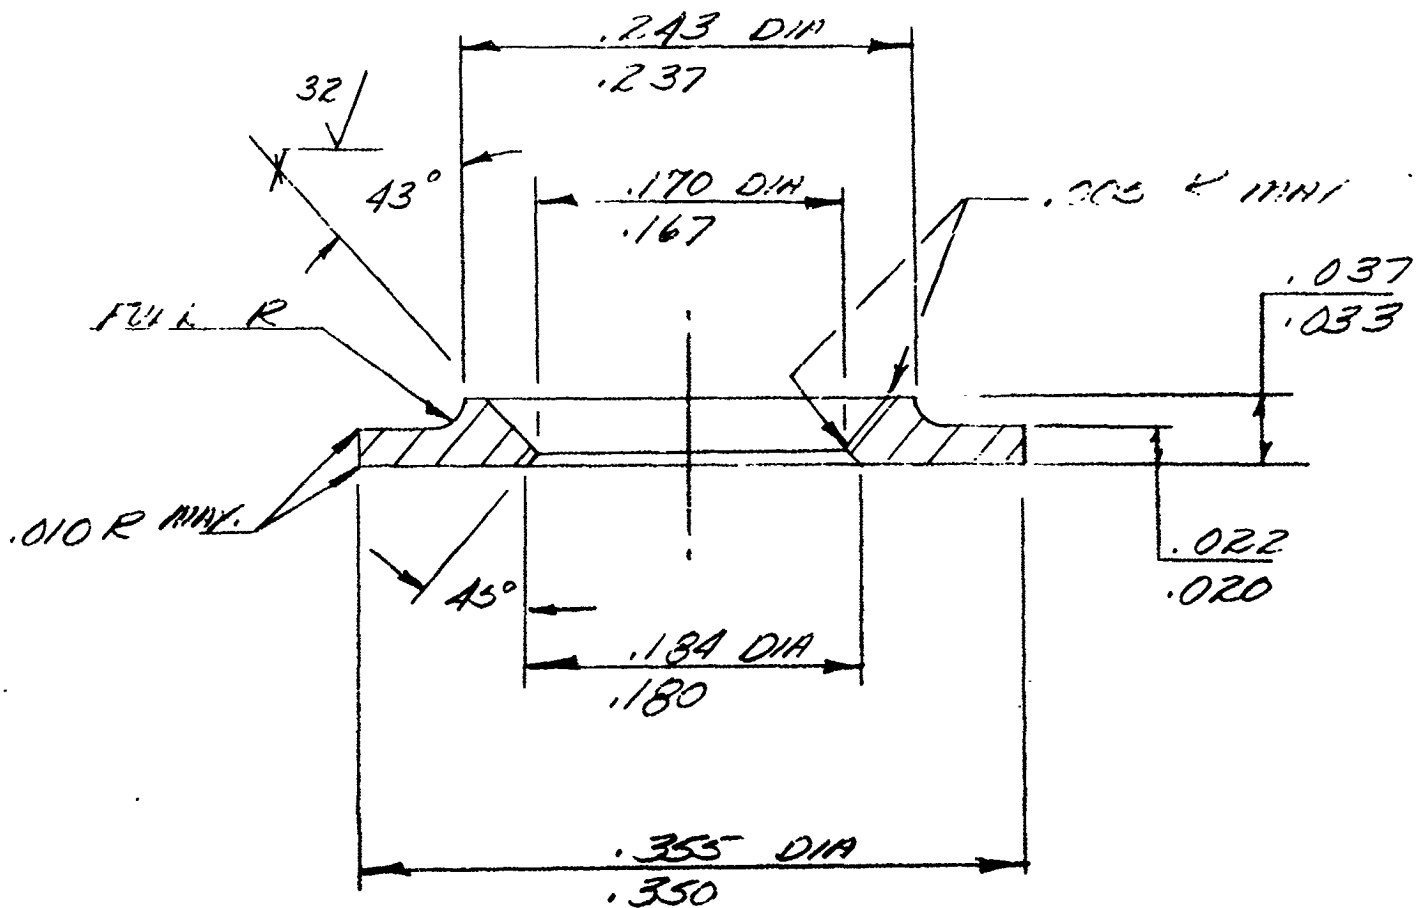
Figure 1

Seat seals of DuPont LRU 488 were molded by JPL in accordance with a TMC-supplied sketch (Figure 1). The configuration of this seal was to provide a seal interface identical with the TFE seal of the Marquardt R4D valve seat assembly (P/N 228683). To substantiate molding accuracy and document critical fit dimensions of the respective seals with the mating parts, seal O.D., I.D. and critical thickness were measured and recorded (Table I). The undersize O.D. dimension indicated material shrinkage which could be compensated for by minor modification of the mold. Seal thickness was slightly oversize but the magnitude appeared to be inconsequential. Under microscopic examination (to 40X) the seal profile was uniform and flash free, with the exception of the outside diameter. A significant quantity of foreign material inclusions were apparent within the seal material (metallic particles and black stringers) but none broke through the surfaces, or appeared to jeopardize the capability of the seal to function.

SEAT SEAL

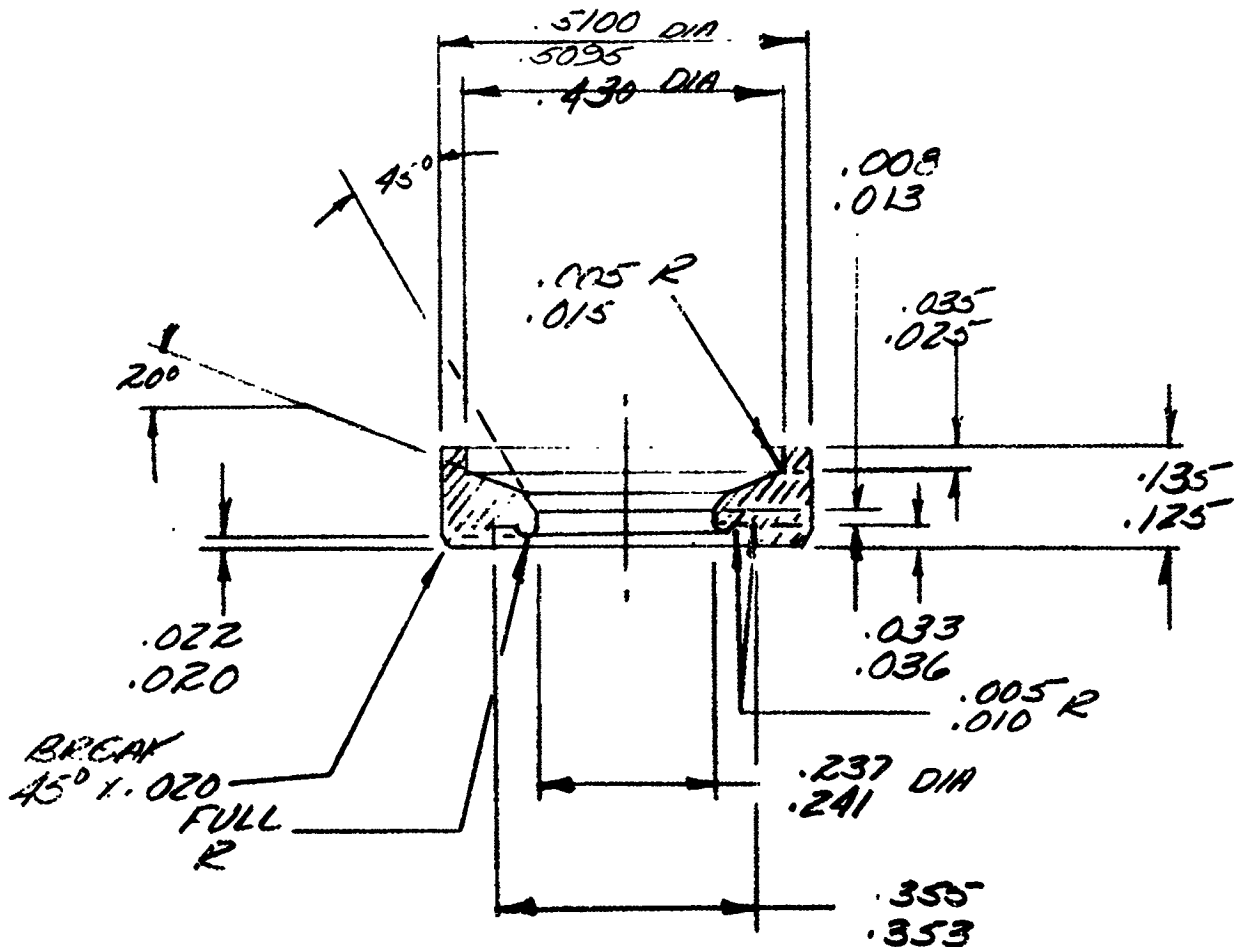
Figure 2

The seat assemblies, from S/N 027 and 208 P/N 2286-3 valves, were removed and machined to remove the inserts and TFE seals in preparation for reassembly with the new seal material. Inserts in accordance with Figure were fabricated. After cleaning all detail parts, seat assembly was accomplished using special tooling and fixtures normally employed in the manufacture of R4D valve seats. Since the normal seat assembly procedure is to assemble the seal into the insert, cool this assembly to less than -200°F , then press it into the seat which is at ambient temperature, this procedure was used to assemble seat S/N 1012 (valve S/N 027). The resultant assembly evidenced cracking of the seal material due to the brittle nature of the material at the cold temperature. The insert and seal were removed and all subsequent seat assemblies were accomplished at ambient temperature.

FAB 4 OF AM 355 VAC. MELT
BAR
OR ENG. APPROVED ALTERNATE

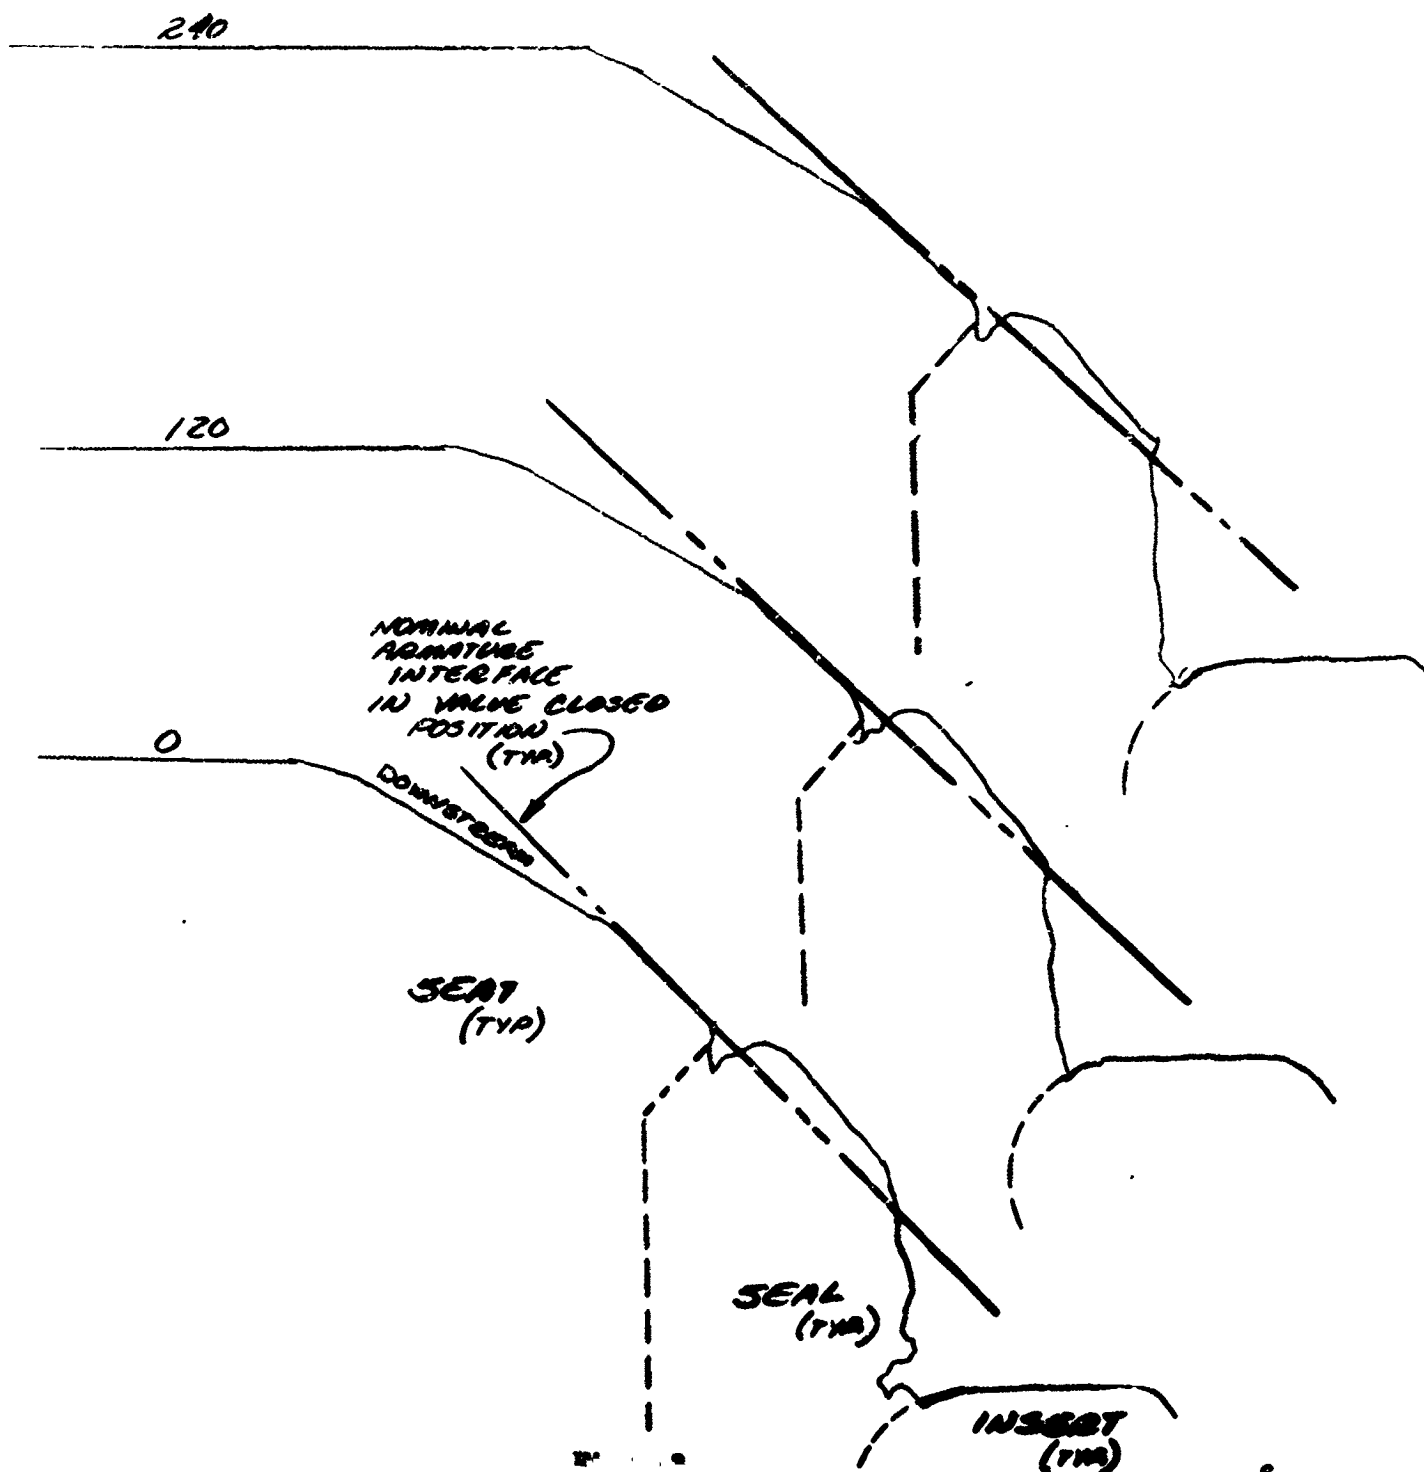
SEAT 3W 042
SEALING SURFACE PROFILE
50 X SIZE

Following the assembly of seat S/N 042 (valve S/N 028), an RTV mold was made of the sealing surface and a profile of the surface traced on a comparitor (Figure 3). To document an accurate profile trace, the seal profile was traced on a Bendix Proficorder (Figure 4). All traces evidenced excellent sealing capabilities (adequate seal "proud"), and the seat was installed in the valve assembly.

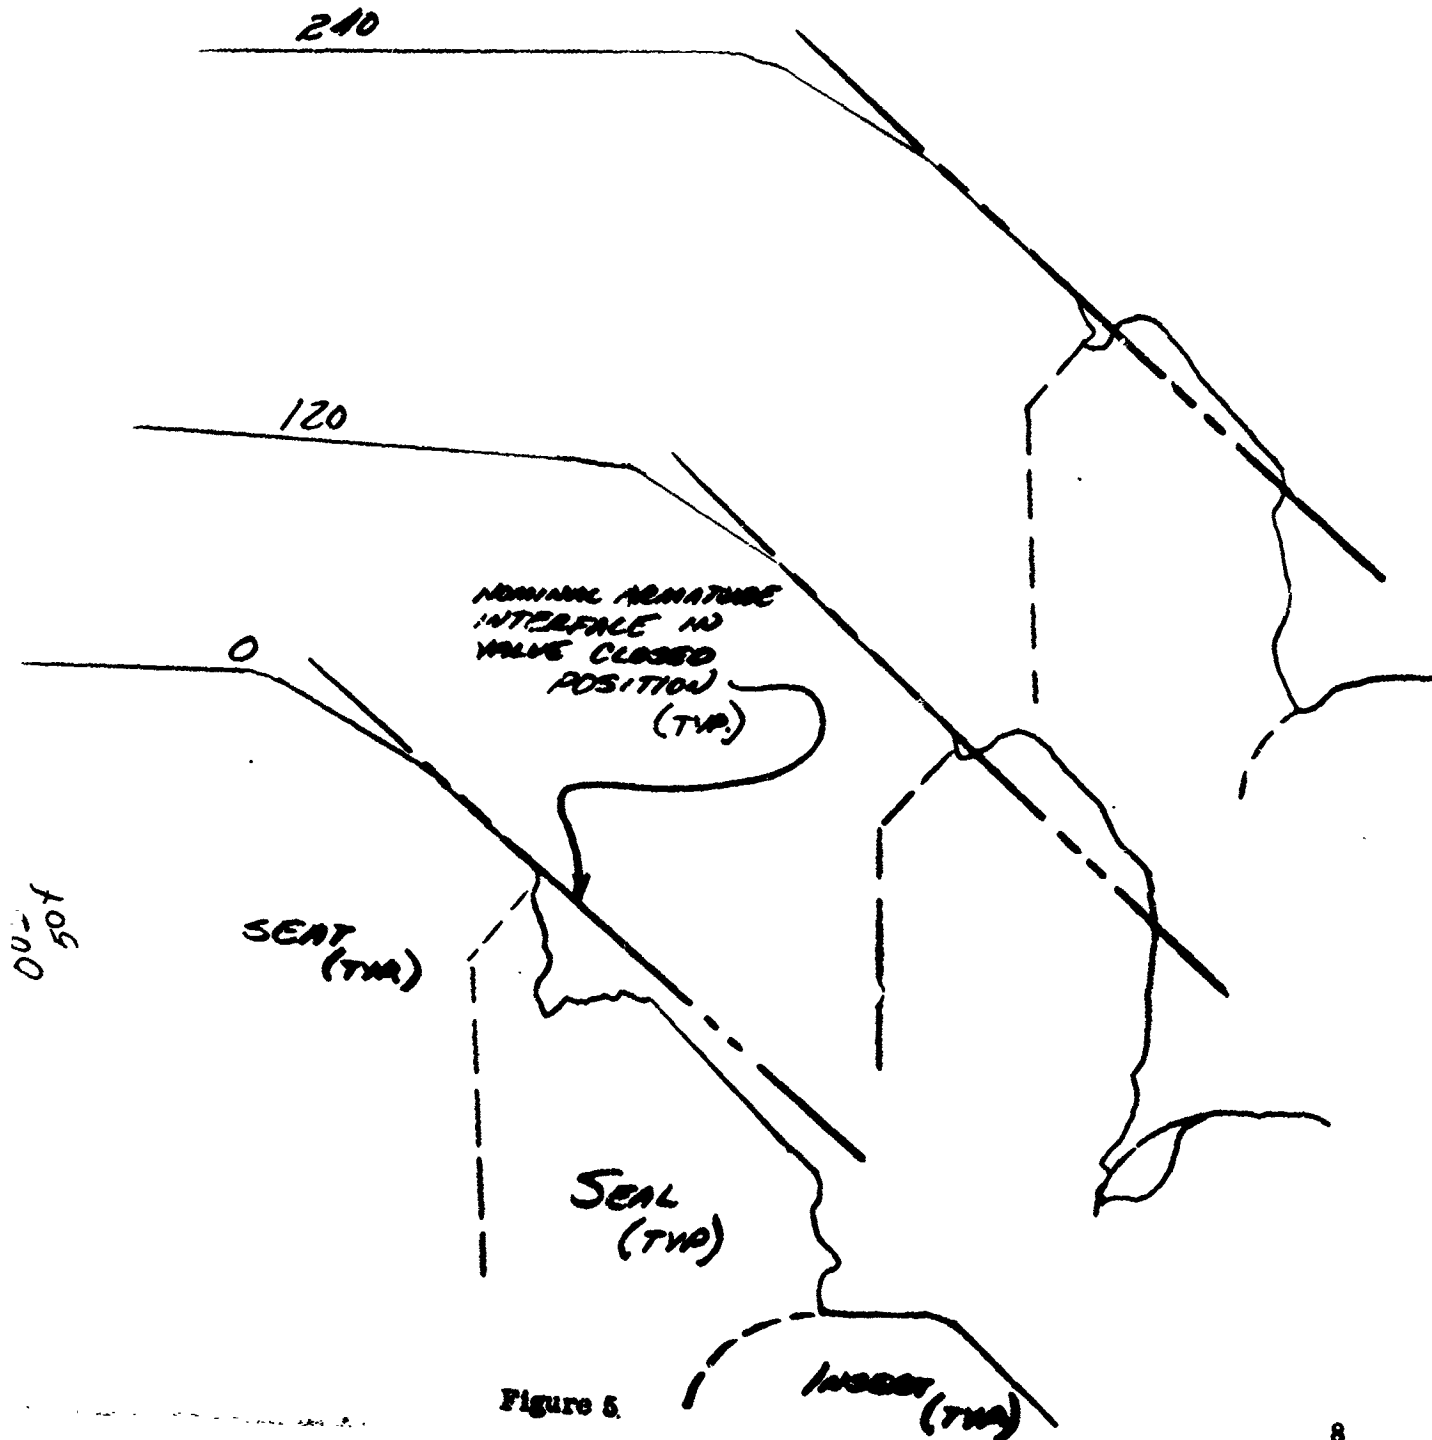
SEAT ASSY. S/N 1012
SEALING SURFACE PROFILE
50X SIZE
S/N 003 SEAL

After reworking seat S/N 1012, reassembly was accomplished at ambient temperature. The RTV mold profile (Figure 5) and Proficorder trace (Figure 6) confirmed the observed eccentric seal condition observed visually. A preliminary leak check of the seat, assembled into the S/N 027 valve resulted in seat leakage in excess of 100 scc/min. at inlet pressures

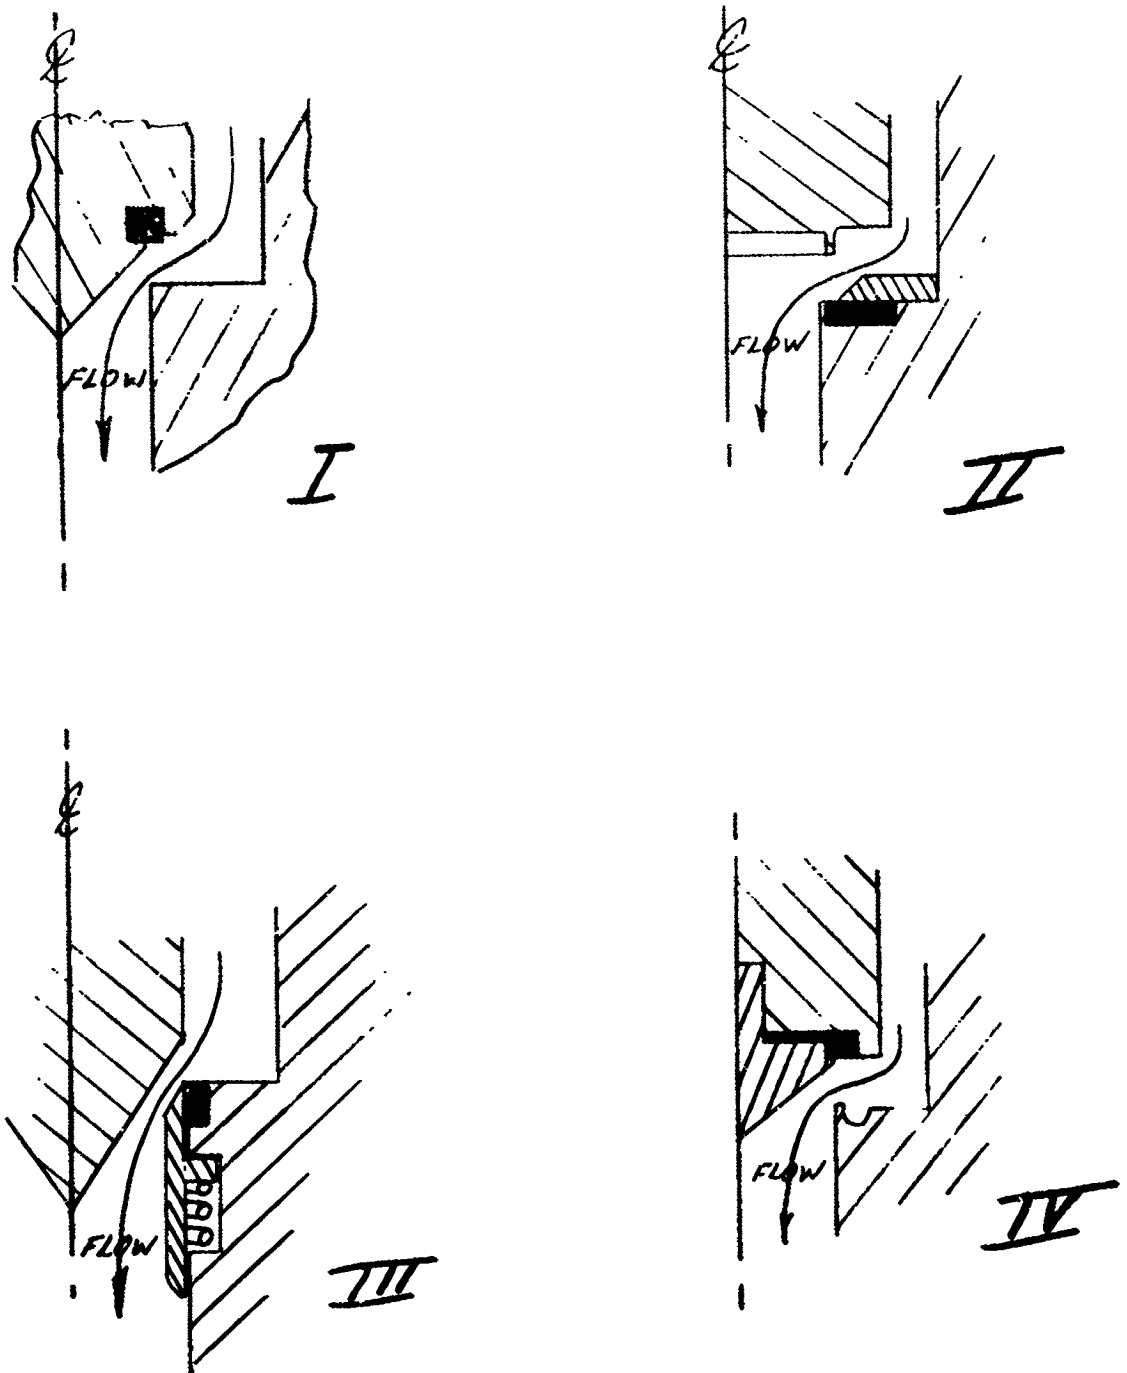
Figure 9

(Figure 9 presents several conceptual designs of seat seals which are consonant with elastomeric seal materials.)

- a. Obtain structural and thermal properties of the material and prepare a design, supported by a design analysis, of a valve seat which will result in overall valve performance comparable to that of the Marquardt R4D valve assembly.
- b. Fabricate evaluation seat designs and conduct an evaluation test program to assess cycle life, temperature, structural margin, and leakage characteristics, utilizing a R4D valve as a basic unit, modified to accommodate the selected seat/armature design configuration.
